YELLOW WATER DAM

MANUAL FOR OPERATION AND MAINTENANCE

**State Water Projects Bureau
Water Resources Division
Department of Natural Resources and Conservation
P. O. Box 201601
1424 9th Avenue
Helena, MT 59620-1601**

**Initial Publication March 1998
Revised September 2007**

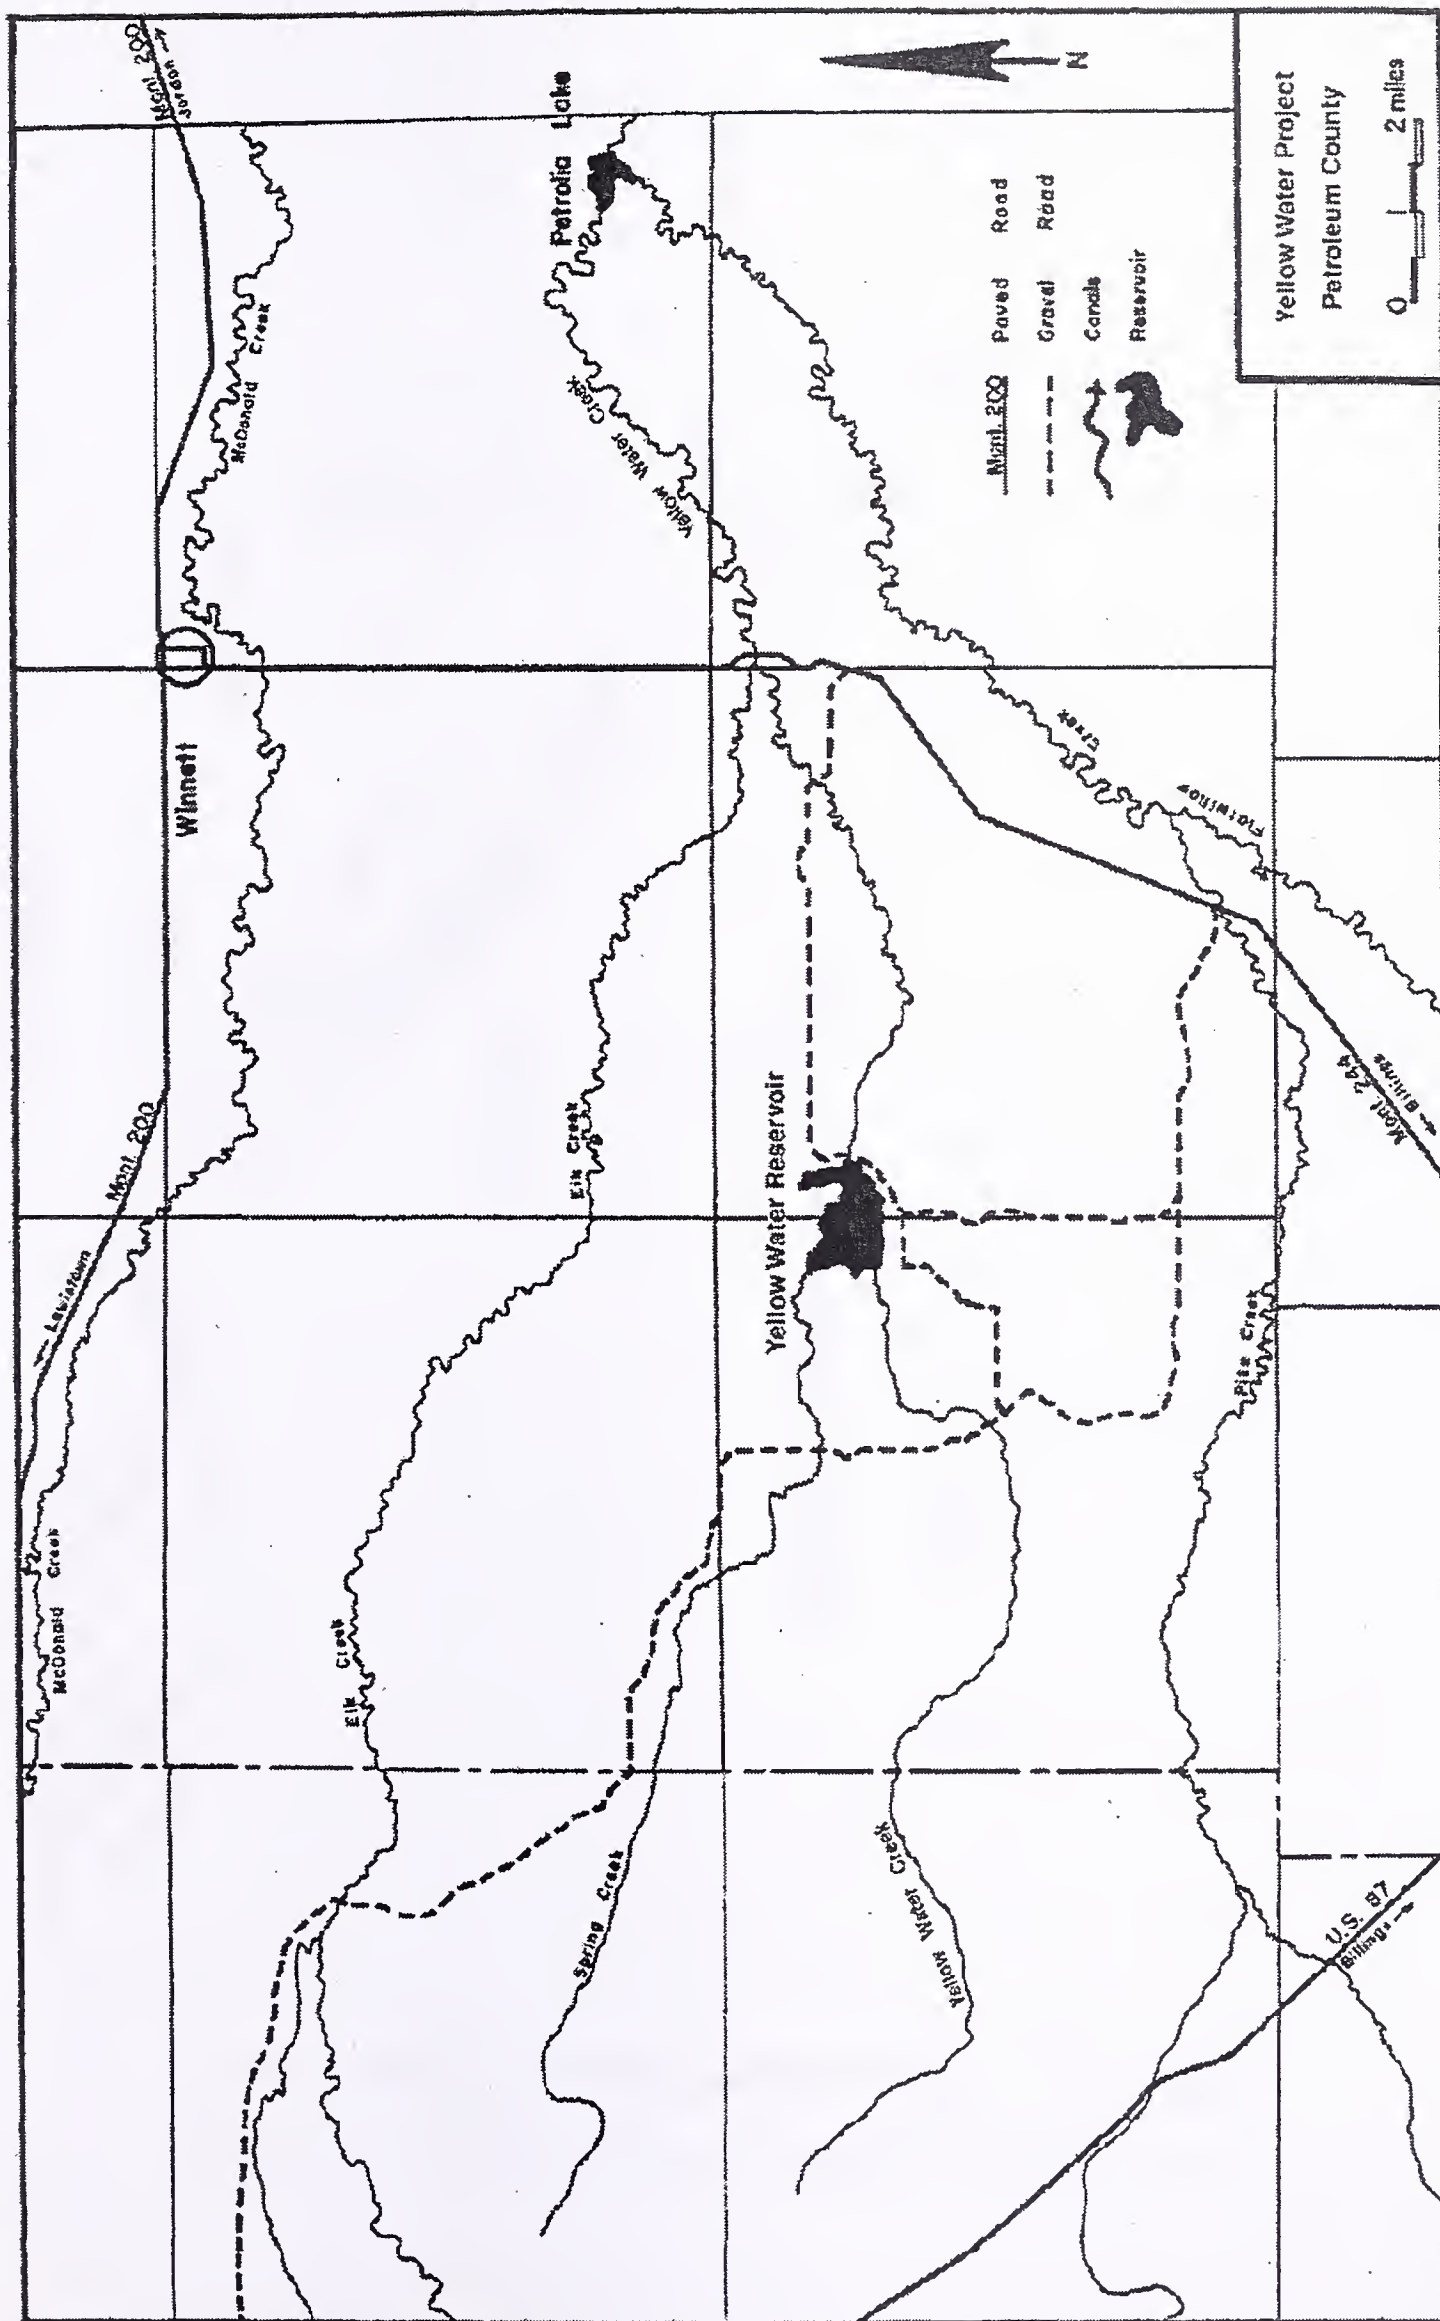
Figure 2. Yellow Water Project Map

Yellow Water Reservoir is located in Petroleum County approximately eight miles southwest of the town of Winnett, Montana (and about six miles west of Highway 244). It is located on and fed by Yellow Water Creek and Snoose Creek. See Figures 1 and 2. Figure 3 provides a general layout of the dam, spillway and outlet works.

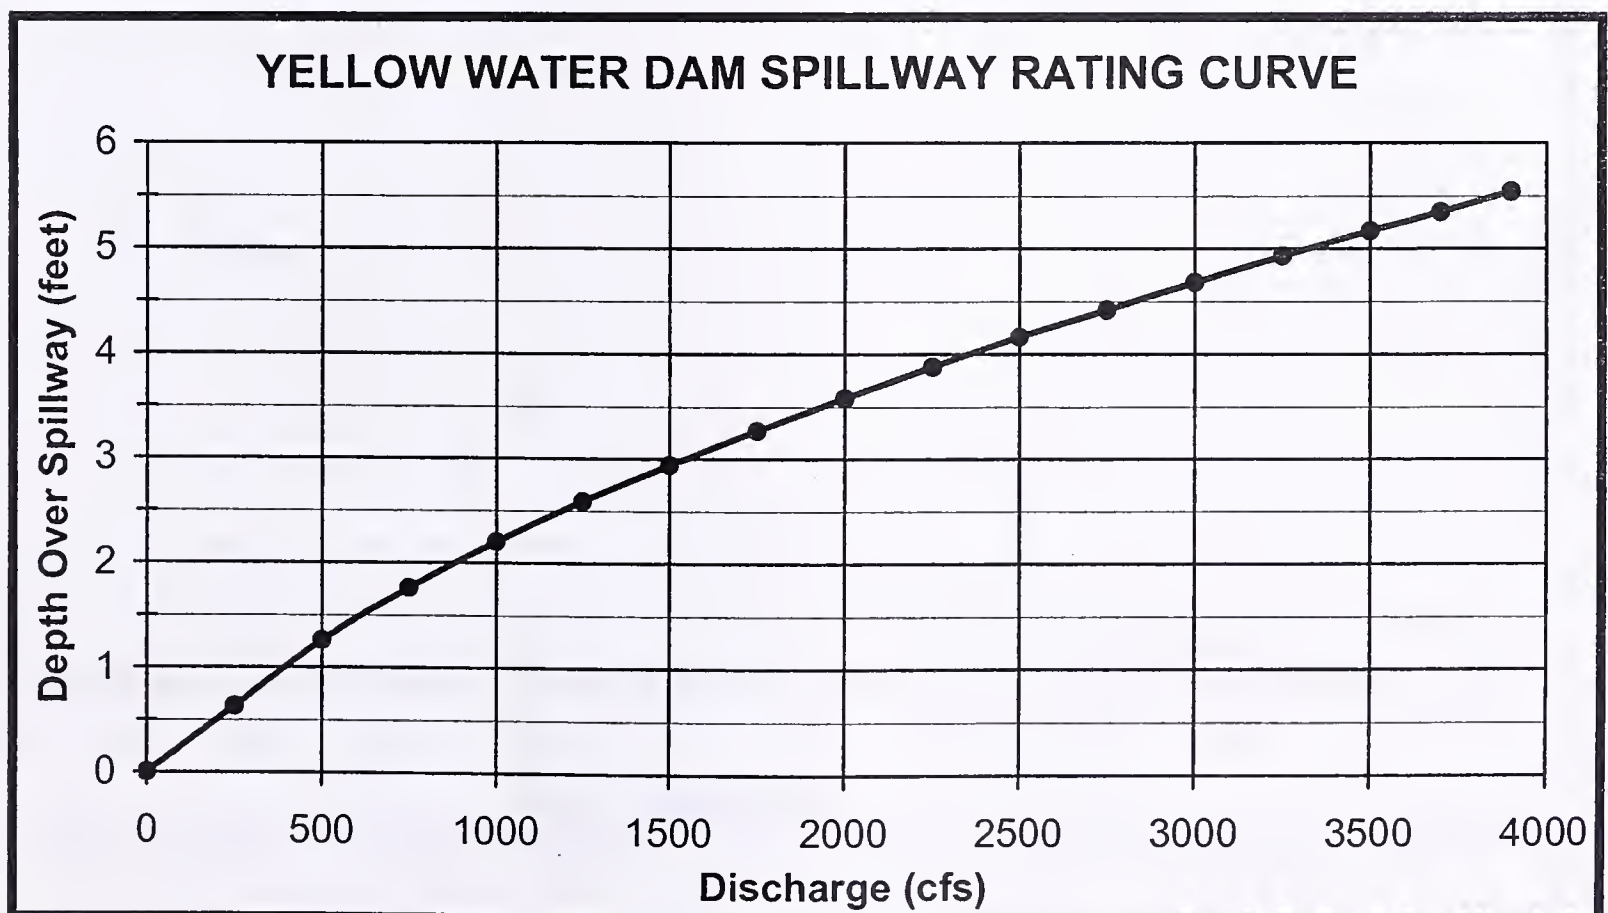
Depth Over Crest (feet)	Elevation (feet)	Discharge (cfs)
0	3118.3	0
0.63	3118.93	250
1.26	3119.56	500
1.76	3120.06	750
2.2	3120.5	1000
2.59	3120.89	1250
2.94	3121.24	1500
3.27	3121.57	1750
3.58	3121.88	2000
3.88	3122.18	2250
4.16	3122.46	2500
4.42	3122.72	2750
4.68	3122.98	3000
4.93	3123.23	3250
5.17	3123.47	3500
5.35	3123.65	3700
5.54	3123.84	3900

Note: Data From 2007 Yellow Water Five Year Inspection by Kenneth Phillips P.E .

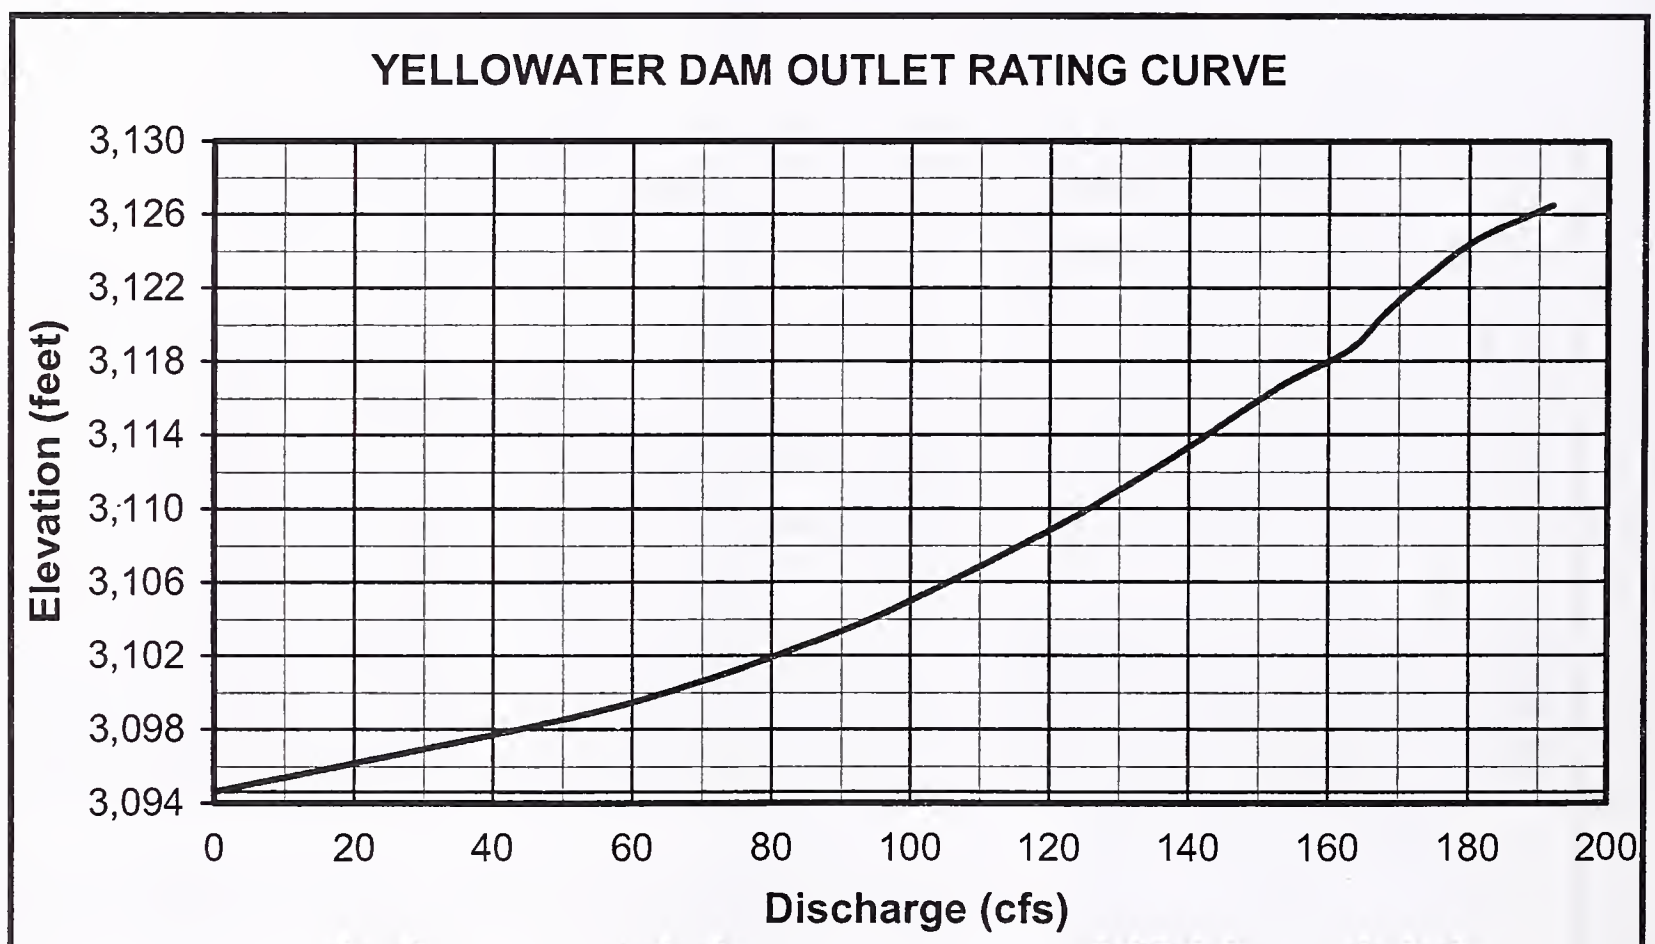
TABLE 3. OUTLET DISCHARGE
YELLOW WATER RESERVOIR

Reservoir Elevation (feet)	Discharge** (cfs)	Comment
3,094.6	0	
3,098.6	51	
3,100.6	70	
3,102.6	85	
3,104.6	98	
3,108.6	119	
3,112.6	137	
3,116.6	153	
3,118.6	163	Spillway Crest
3,120.6	168	
3,122.6	174	
3,124.6	181	
3,126.5	192	Maximum Dam Crest

**Discharge assumes operating gate is in fully open position.

Note: Data from the Corps of Engineers Phase 1 Inspection Report (1980).

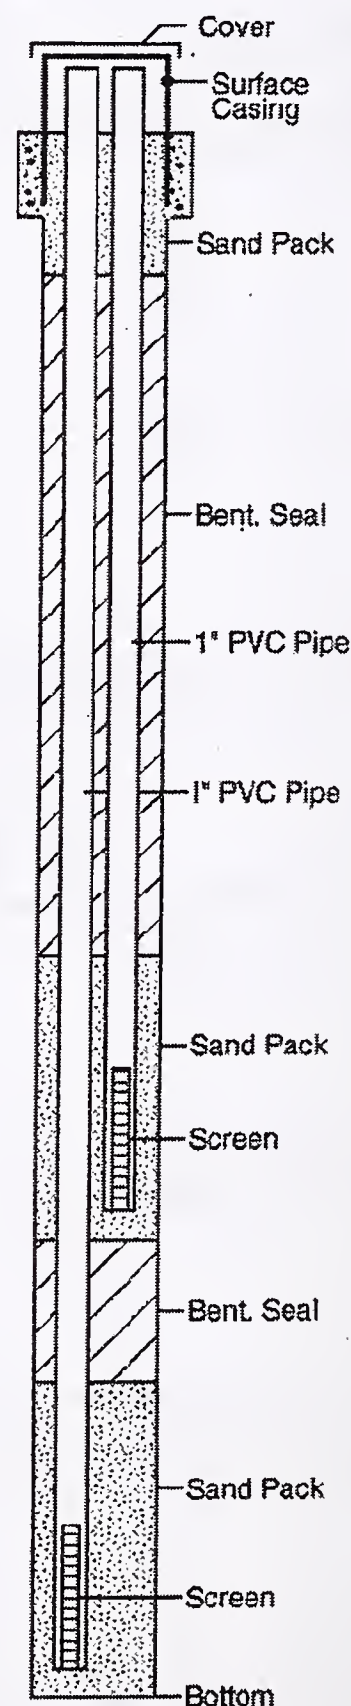
WELL COMPLETION LOG NO: DH1

Well1: DH-1D
Well2: DH-1S

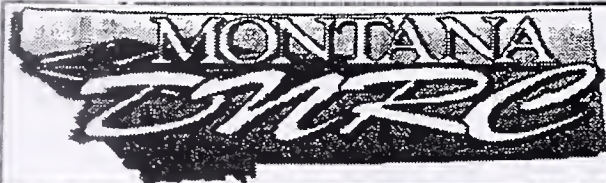
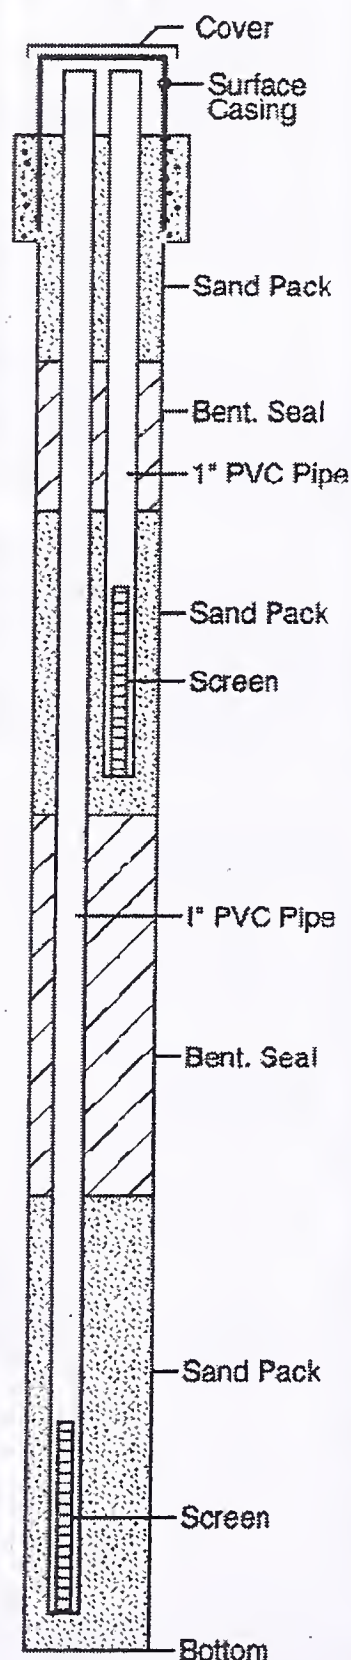
WELL COMPLETION LOG NO: DH2

Well1: DH-2D
Well2: DH-2S

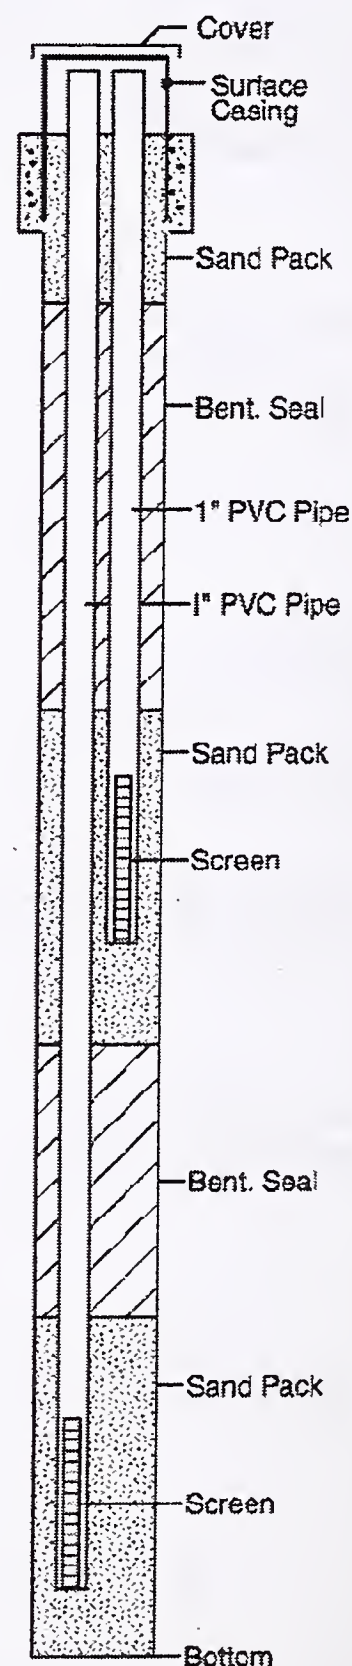
WELL COMPLETION LOG NO: DH3

Well1: DH-3D
Well2: DH-3S

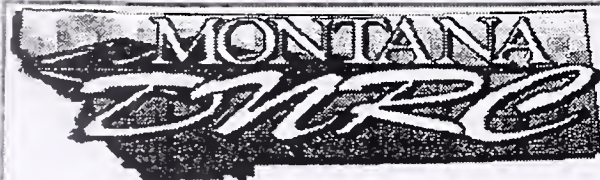
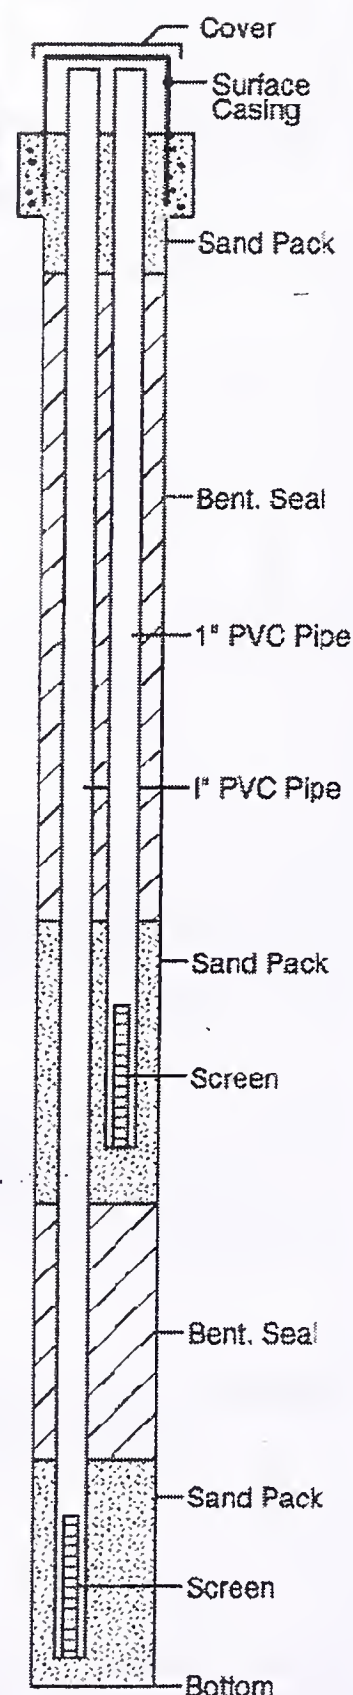
WELL COMPLETION LOG NO: DH4

Well1: DH-4D
Well2: DH-4S

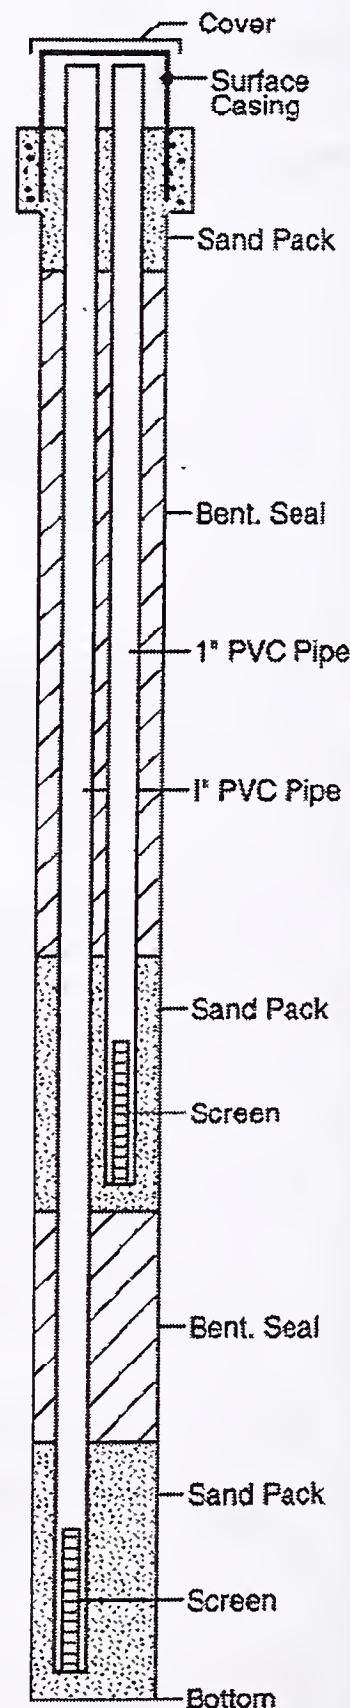
WELL COMPLETION LOG NO: DH5

Well1: DH-5D
Well2: DH-5S

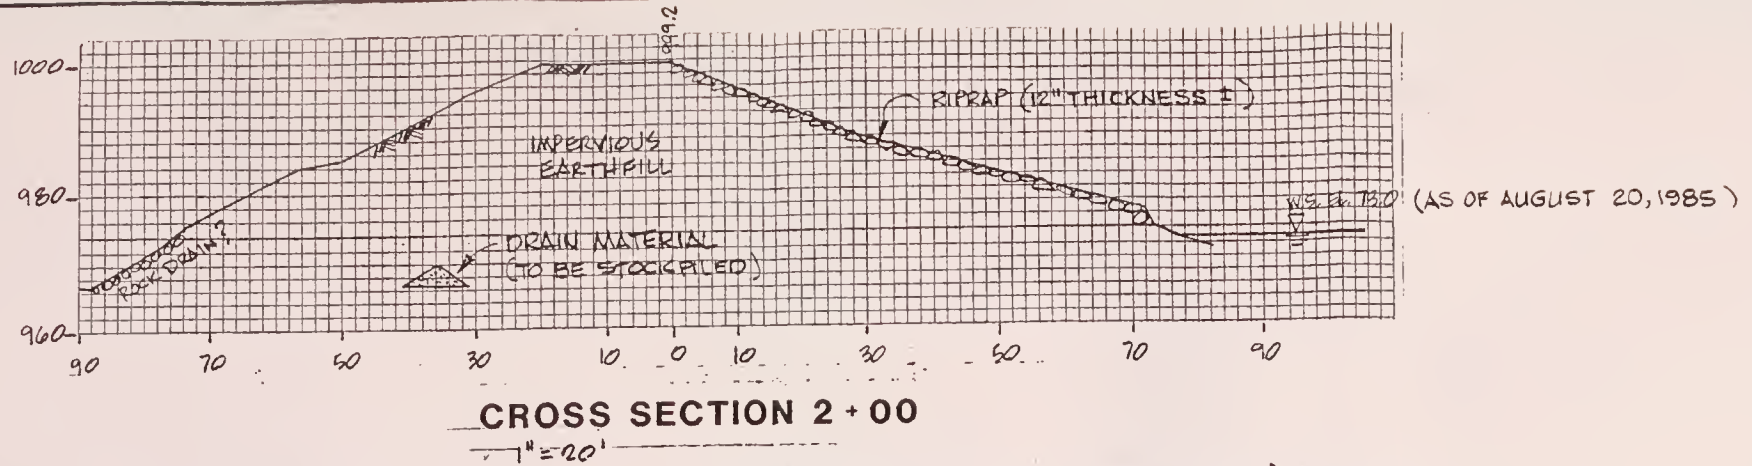
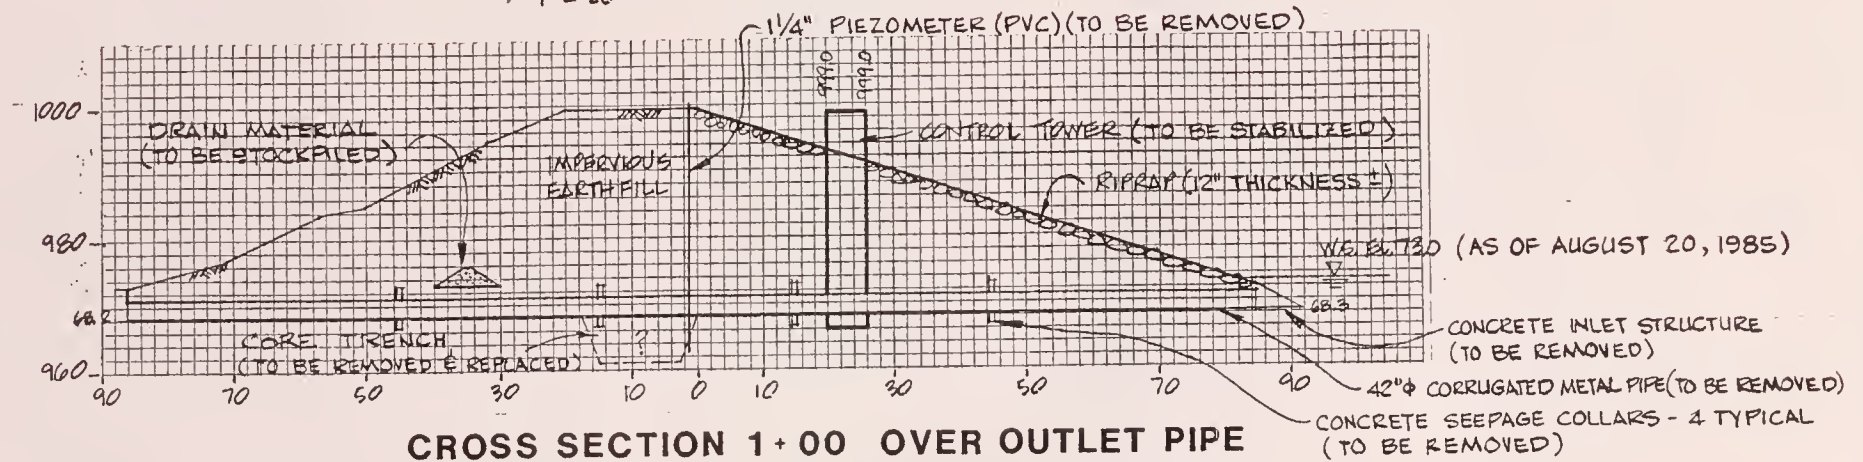
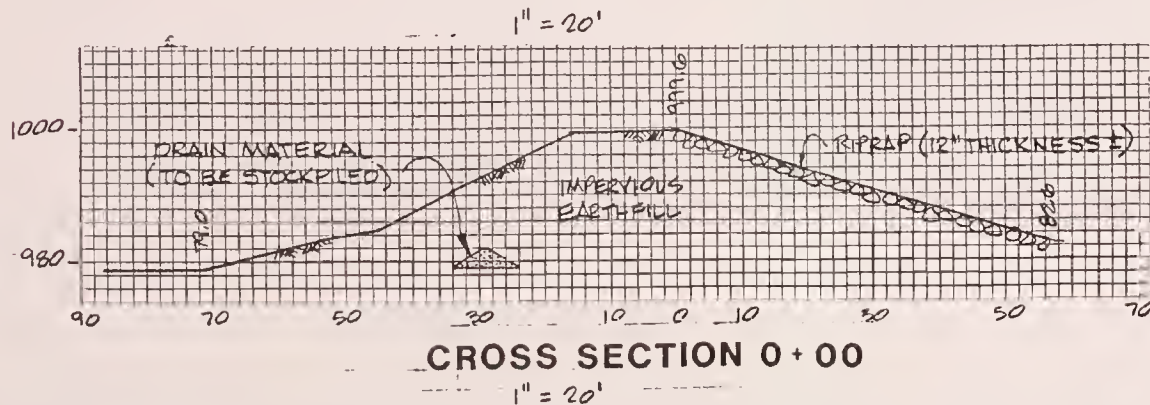
DEPARTMENT OF NATURAL RESOURCES & CONSERVATION DNRC PROJECT NO. 166.001		DRAWN JMH
YELLOW WATER DAM OUTLET REPLACEMENT		DESIGNED PPP
PHASE ONE CROSS SECTIONS		DATE 8-27-85
MORRISON-MAIERLE, INC. CONSULTING ENGINEERS		PROJECT NO. 1447-02-01

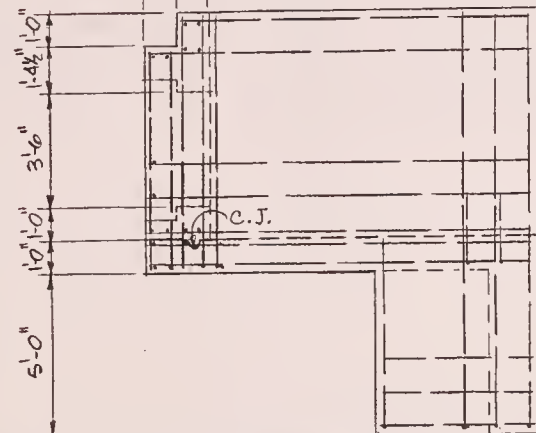
ELEVATION B-B

OUTLET STRUCTURE DETAILS

<p align="center">DEPARTMENT OF NATURAL RESOURCES & CONSERVATION</p> <p align="center">DNRC PROJECT NO. 168.002</p>	
<p align="center">YELLOW WATER DAM OUTLET REPLACEMENT PHASE TWO OUTLET STRUCTURE & PIPE BEDDING DETAILS</p>	<p align="center">DRAWN JMH</p>
	<p align="center">DESIGNED PPP</p>
	<p align="center">DATE 9-23-85</p>
	<p align="center">PROJECT NO. 447-012-01</p>

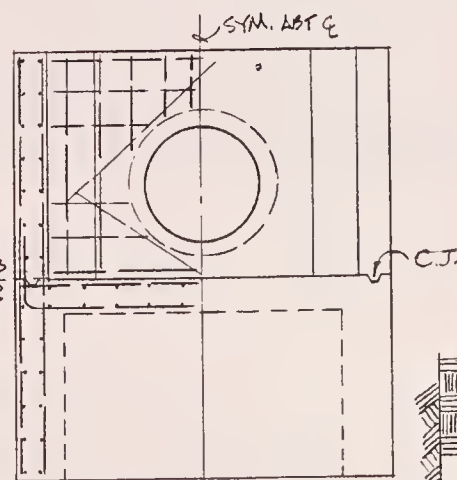
ELLVATION C-C

FOUNDATION PREP.

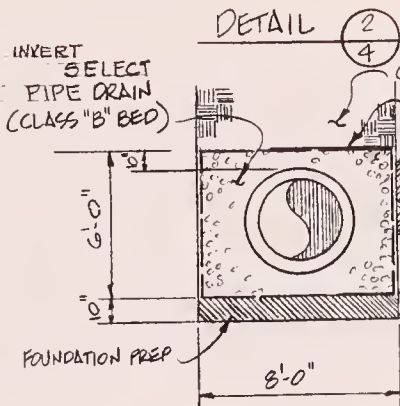
DETAIL (4)

PIPE BEDDING DETAILS
 $\frac{3}{16}'' = 1'-0''$

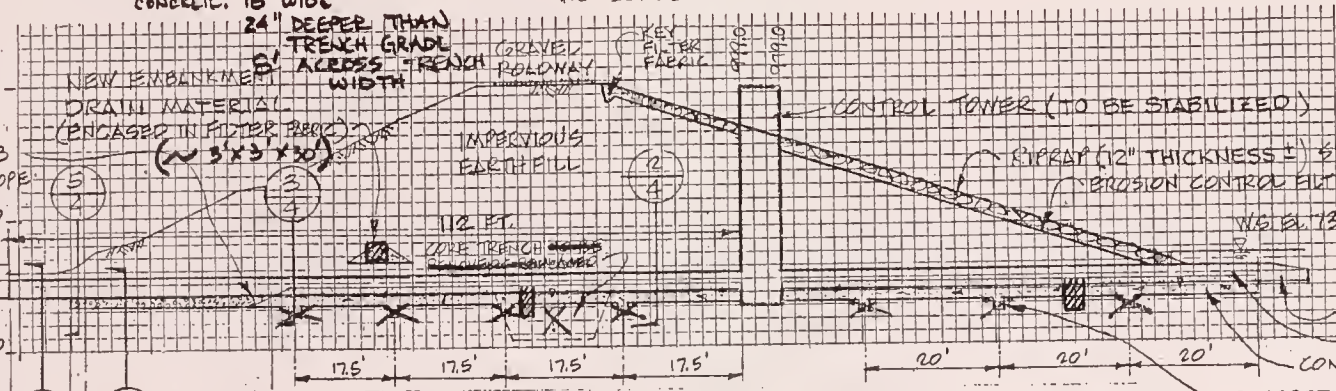
CROSS SECTION 1+00 OVER OUTLET PIPE

70' FROM TOWER MAKE
TRANSITION FROM CONC.
PIPE BEDDING TO CLASS B
BEDDING REQUIRES 3:1 SLOPE

OUTLET STRUCTURE
SEE DETAIL (1/4)

CONCRETE FLARED END SECTION
42" RCP
CONCRETE PIPE BEDDING SEE DETAIL (2/4)
CONCRETE SEEPAGE CUTOFF (4'x8'x1.5')
SEE DETAIL (3/4) TYP.

DEPARTMENT OF NATURAL RESOURCES & CONSERVATION DNRC PROJECT NO. 188.002	
YELLOW WATER DAM OUTLET REPLACEMENT PHASE TWO CROSS SECTION

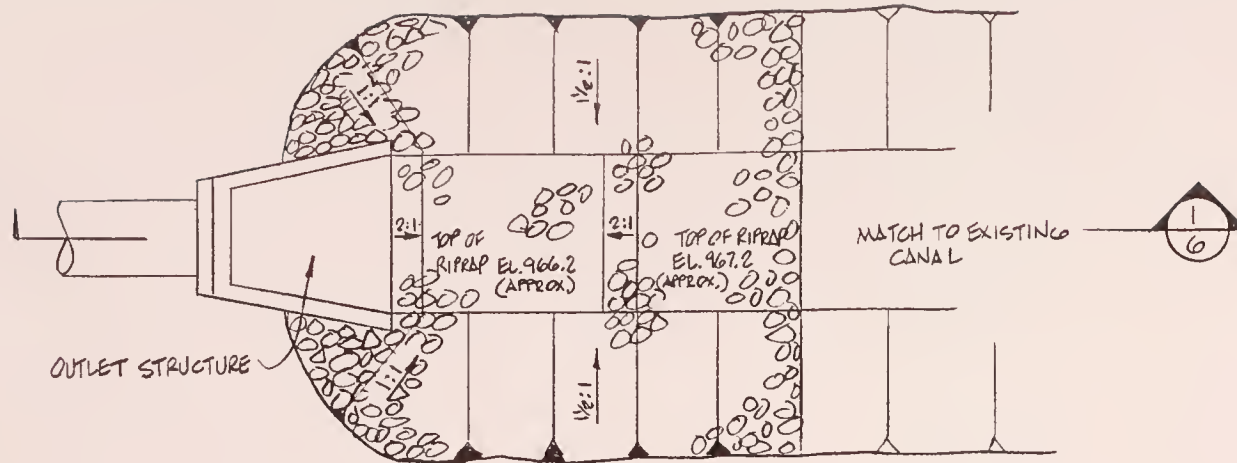
OUTLET BASIN PLAN

YELLOW WATER DAM
OUTLET REPLACEMENT
PHASE TWO
OUTLET BASIN DETAILS
